PLEASANT LAKE DAM

NH 00362

PHASE I INSPECTION REPORT  
NATIONAL DAM INSPECTION PROGRAM

NOVEMBER 1978

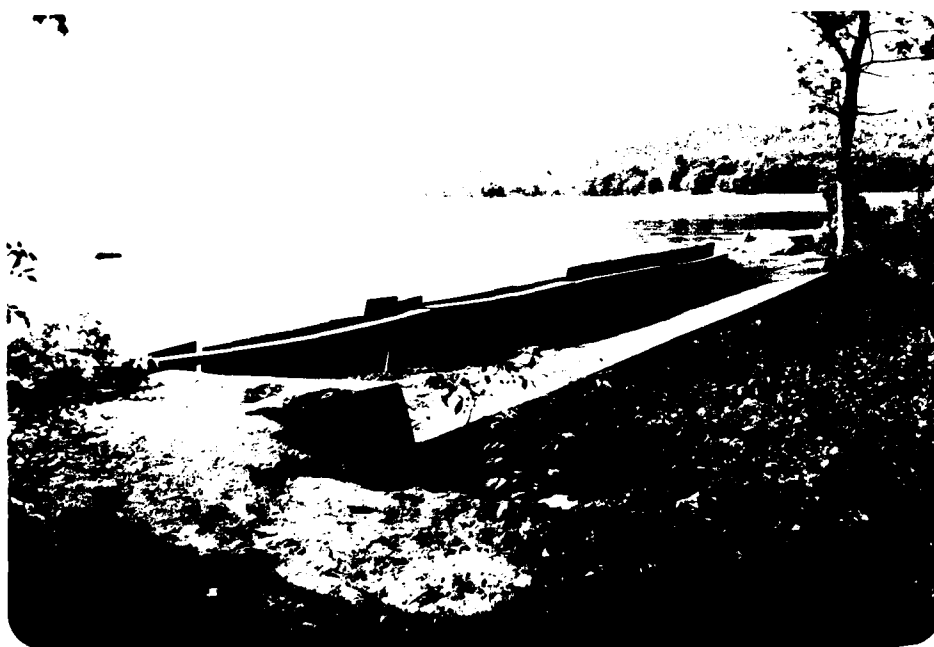
Overview of spillway from right side

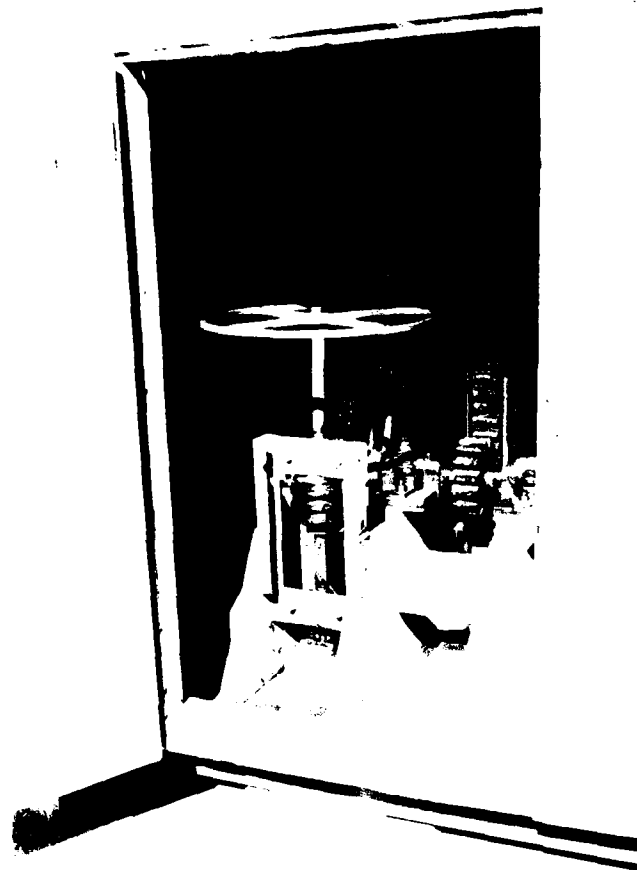
The deterioration of the steel sluice gate led to the NHWRB recommending that it be removed after construction of the stoplog weir. The present weir requires little maintenance. While the sluice gate serves no further purpose, its mechanical operating system was rebuilt 5 years ago and is very well maintained.

5. View of gate operating mechanism
